**Flood Control Project Maintenance  
Levee Inspections**

**Fall 2019 Levee Maintenance Deficiency Summary Report**

**San Joaquin River Basin**

**Reclamation District No. 2094 Walthall**

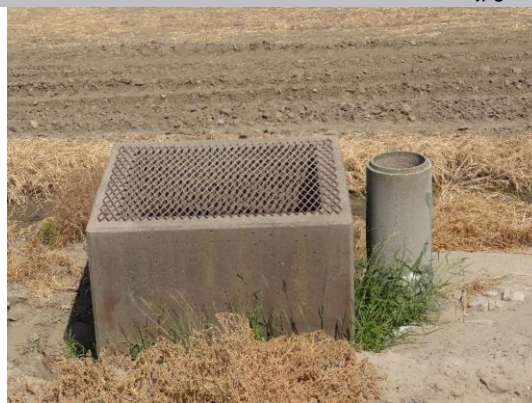
Photo 2 of 3 : UCIP\_FA\_2019\_21545\_36528.jpg

LM Start	2.45	Rating **	M	Issue No.	16 (cont)
LM End	2.45	Issue Type +	En	Location *	
Category	Supplemental			GPS Latitude/Longitude	
				Start	End
Item	DRAFT DWR UCIP Field Study			37.752308°	37.752308°
				-121.293191°	-121.293191°
DWR ID	23089				
Comment Code					
Inspector Comment					
DS_ID:23089 FS_ID:21545 EP_NO: N/A Repair Type: Non-Urgent Crossing Status: Found UCIP Comments: - no pipes found on either side of the levee.- concrete distribution box on LS. Soil erosion around distrinution box. FIELD_STRUCT_DESC: Rectangular concrete distribution box on the landward toe FS Date: 9/10/2013
